## HISTORIC PRESERVATION CERTIFICATION APPLICATION PART 1 — EVALUATION OF SIGNIFICANCE

Maryland House Apts.

Maryland House Apartments 200-204 Washington Street Havre de Grace, Maryland 21078

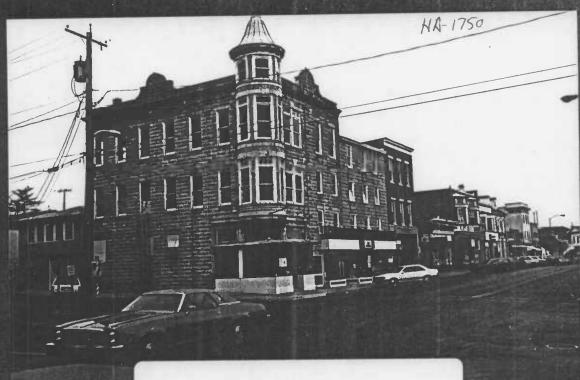
#1 South & East Facade

200-204 Washington Street Property Address	
This building has a comanding present boldness contributes to its landmark with a turet located on the Southeast providing protection for the first flood changed over the years to a door in adorns the base of the turet as well lights of pale pink/purple glass appearance front windows. The second and facade are one over one light with tradummies' as no access is provided in double windows have key stone lentils turet is topped with a copper roof and and east facade has a dentil frieze. buildings in the treatment. The east	ton Street "Corner Building" ce in the local business district. Its Romanesque status. The building is a three story structure corner. The turet beings on the second itsor cor corner entrance. The corner entrance has been the center of the east facade. Intricate tin work as the facade of the turet between floors. Small ear to be original in the transoms of the original third floor windows of the turet and the east iple light transoms. The top turet windows are the original construction. The east facade that appear to man-made and not granite. The d a weather vane finial. The cornice on the South Note that the east facade includes the center and South roof lines have one dominate stone dominance of the structures. (continued on page "A")
